### 2.1 Northbound and Southbound Tunnels from the Tagore Cut and Cover to Springleaf Station Box

### 3 SLURRY SHIELD TBM FOR T208

## 4 CHALLENGES ENCOUNTERED ON T208

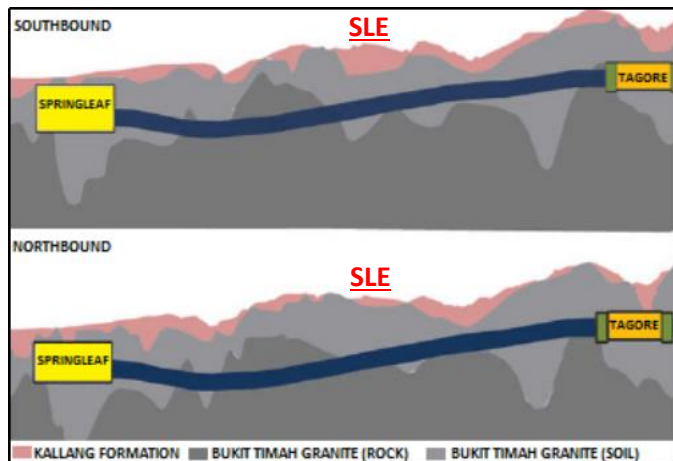
Figure 3: Geotechnical Conditions for the Northbound and Southbound Tunnels from Tagore to Springleaf

Geotechnical conditions were similar along the two alignments, and consisted of weathered soil and rock derived from the Bukit Timah Granite Formation as shown in Fig. 3. This formation was located below a localised layer of the Kallang Formation which itself consisted of marine and alluvial clays.

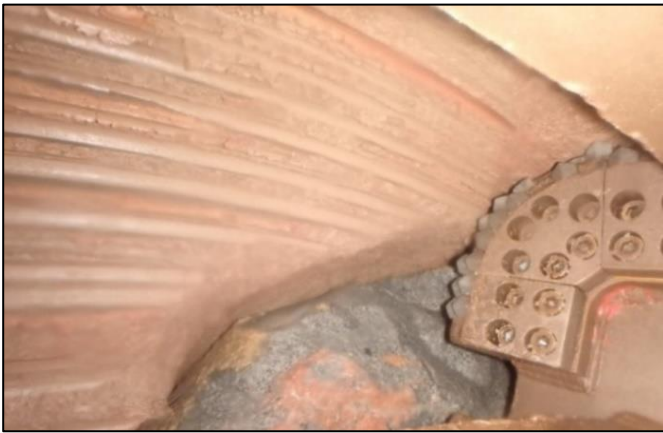
Figure 7: The application of a good bentonite face provides minimises slurry and air losses

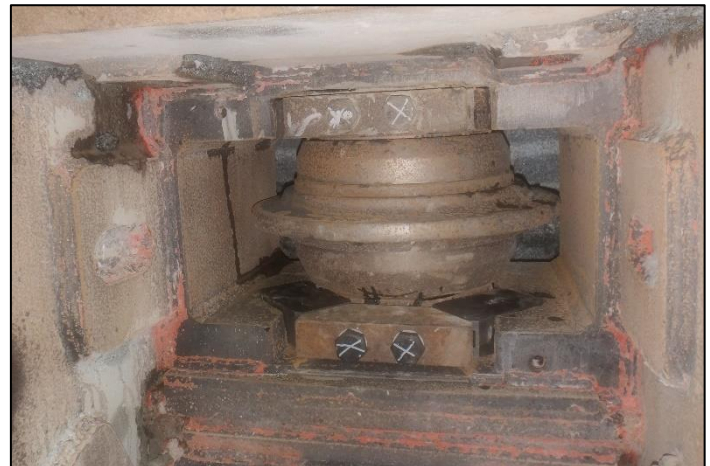
Figure 9: Double wedge block system was used to secure the 19inch disc cutters in the housing

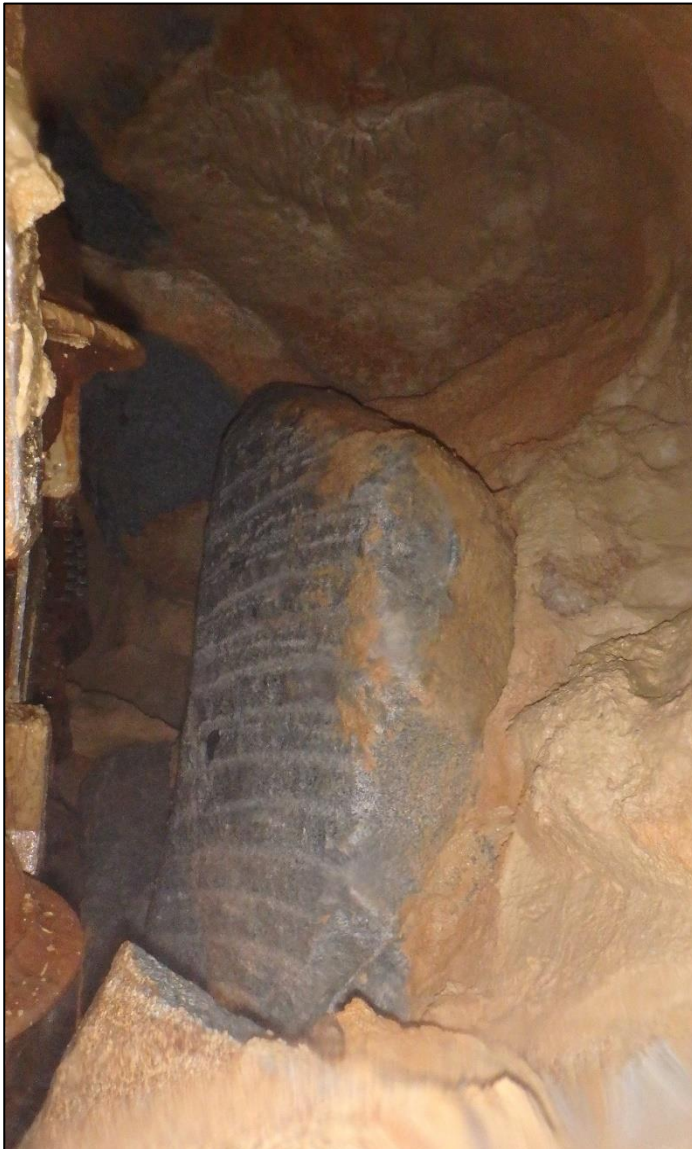
Figure 10: Large boulder encountered in front of the excavation face

The excavation profile of the machine is enlarged from the movement of boulders around the periphery of the shield and in front of the TBM cutterhead, as shown in Fig. 10. These boulders tended to displace the weathered soils creating voids above and in front of the tunnel axis. Until these boulders are either pushed outside of the excavation face or broken up, they

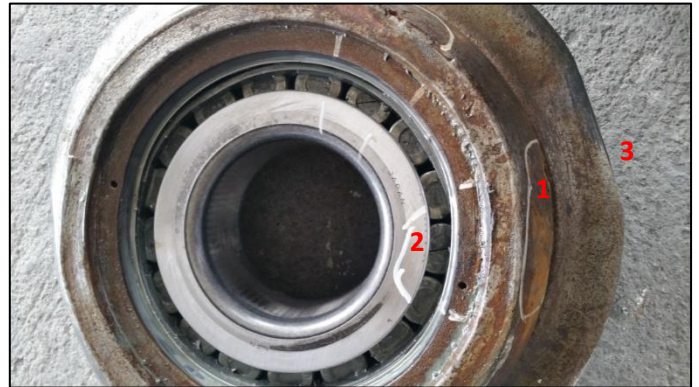
Figure 11: Damaged or worn hubs (1) can cause bearings to either seize or crack (2), resulting in flatspotting of the retaining ring (3)

These boulders would routinely smash against the disc cutters and split the retaining rings, eventually destroying the disc cutter. Other issues included exposed disc cutters hubs that would crack the bearings if they were damaged, eventually leading to flatspotting on the disc cutter, as shown in Fig. 11.

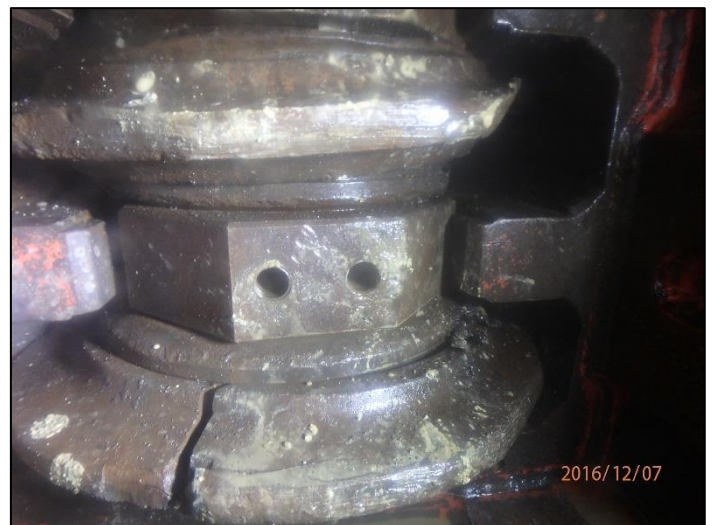
Figure 12: Loose and fallen wedges can further damage disc cutters

These boulders would also cause the wedge locking system to loosen, or shear the retaining bolts, as shown in Fig. 12. These loose wedges would either then jam in the housing, or they would fall and circulate around the cutterhead. This would often cause further damage to tooling and the stone crusher, or cause blockages along the slurry circuit, until they were eventually discharged at the STP muck pit.

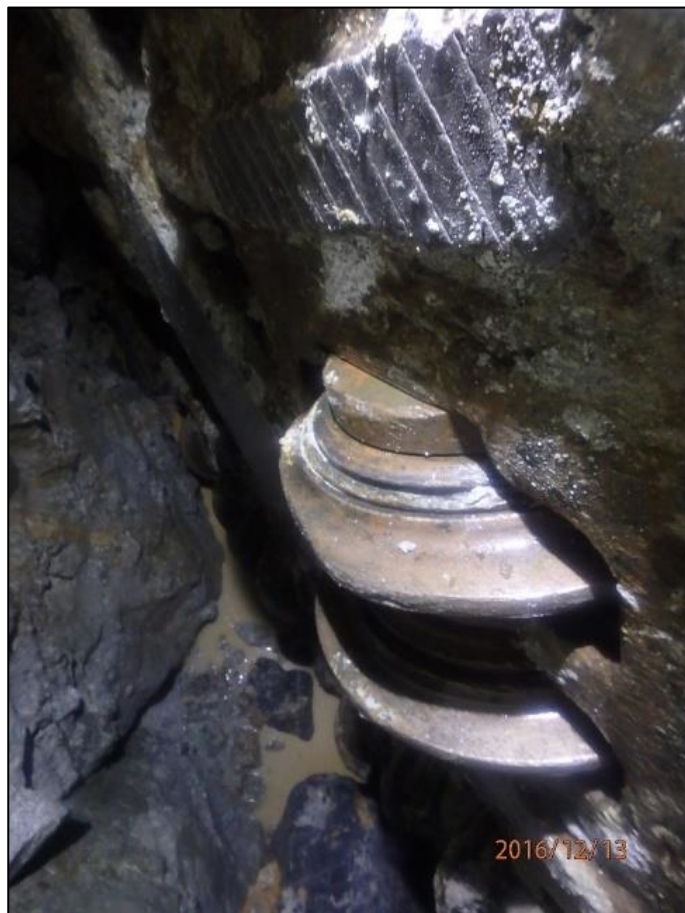
Figure 13: Flatspotting of a double disc cutter in the mixed ground. Note the exposed hub, which is prone to damage and wear

The high replacement rate of disc cutters in the mixed ground was due to flatspotting and split retaining rings, and exceeded initial estimates.

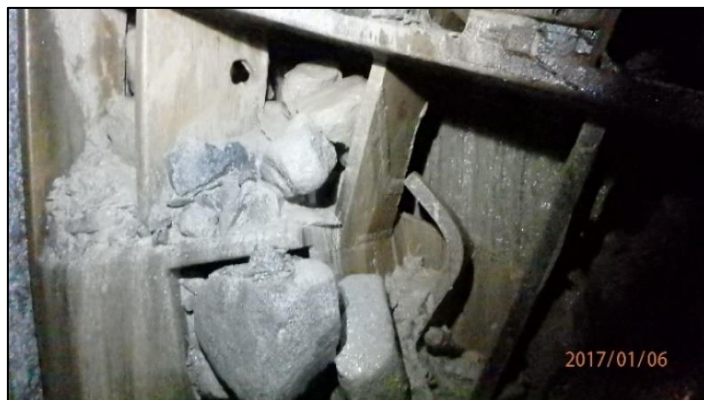
Figure 14: Damaged and bent grizzly bars allowing boulders larger than 250mm to enter the excavation chamber

Damaged and bent grizzly bars, as experienced on both tunnel drives, would allow boulders from 500 to 700mm to rapidly converge into the excavation chamber, as shown in Fig. 14. These smaller boulders would overwhelm the mixing arms, blocking the bubble gate and the crusher, as shown in Fig. 15. These blockages would require frequent compressed air interventions to manually clear the boulders and repair the grizzly bars.

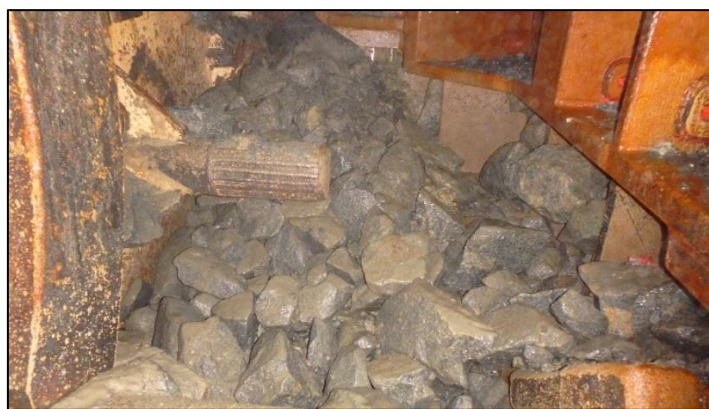
Figure 15: Blocked excavation chamber and bubble gate from smaller boulders

As the bubble gate is severely blocked and the stone crusher unable to function as intended, the flow in the bentonite feed and slurry discharge lines is now restricted, causing pressure fluctuations and activating bypass mode, as shown in Fig. 16. This sudden stoppage and isolation of the TBM from the slurry circuit also causes a pressure wave (water hammer) to propagate down the slurry circuit. These pressure waves will continue until the blockage is cleared, delaying the advance of the TBM and causing problems from noise and vibrations to damaging inline extraction pumps.

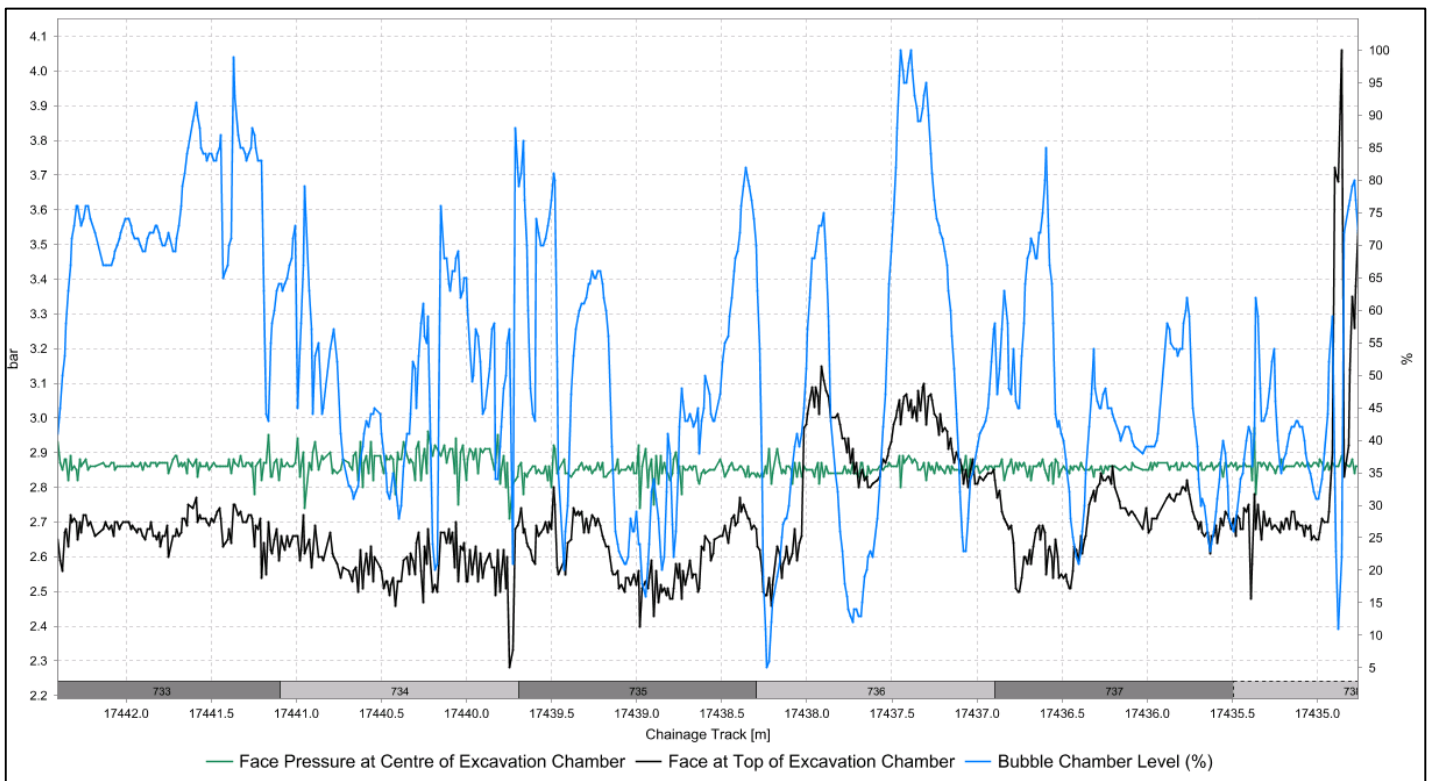
Figure 16: Fluctuations in the bentonite slurry level will be transferred to the excavation face. Inconsistent pressures can lead to over-excavation or blow outs as shown

Any fluctuations in the bentonite slurry level or the air bubble pressure when mining will be transferred to the excavation face [5]. Inadequate face pressures can lead to over-excavation, creating a large void in the excavation face. Increased face pressures can breach blow out limits causing slurry leakage to the surface.

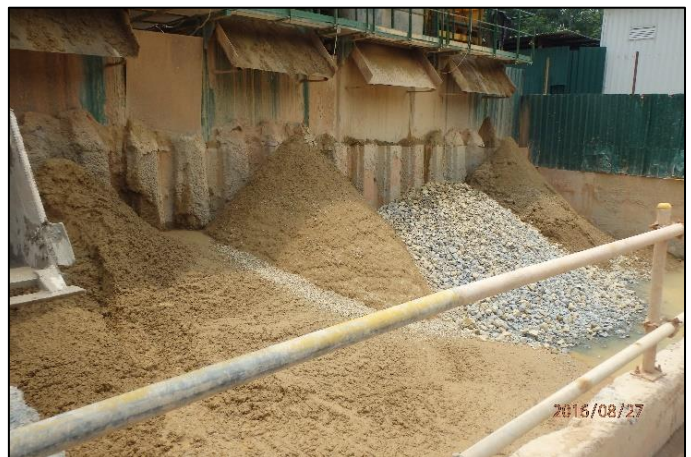
Figure 18: Manual volume checks at the STP in regular intervals supports the MRS. Any inconsistencies between the two systems can be determined

The STP muck pit is visually inspected 2 to 4 times per excavation cycle, as shown in Fig. 18. Manual volume checks are performed measuring the coarse and sand material that is discharged at the STP.
