Building around existing tunnels

Basement excavation analysis potential impact on the North Georges River Sewer tunnel

Sydney, 27 April 2023

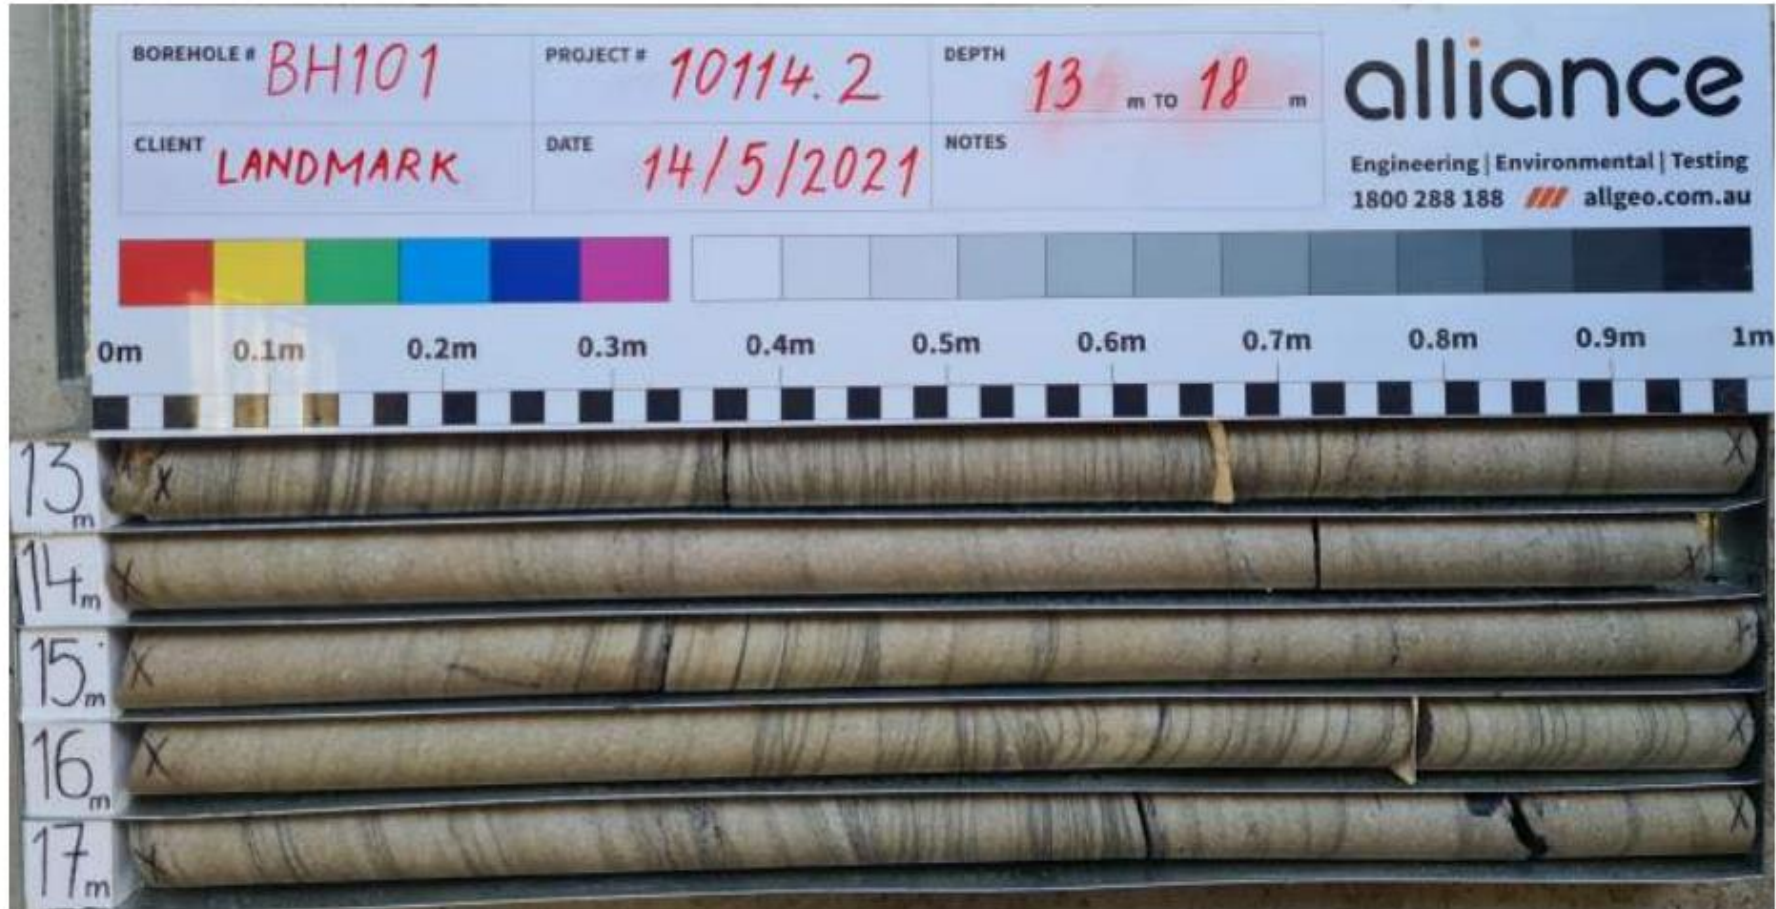
Core Box Photo – BH101

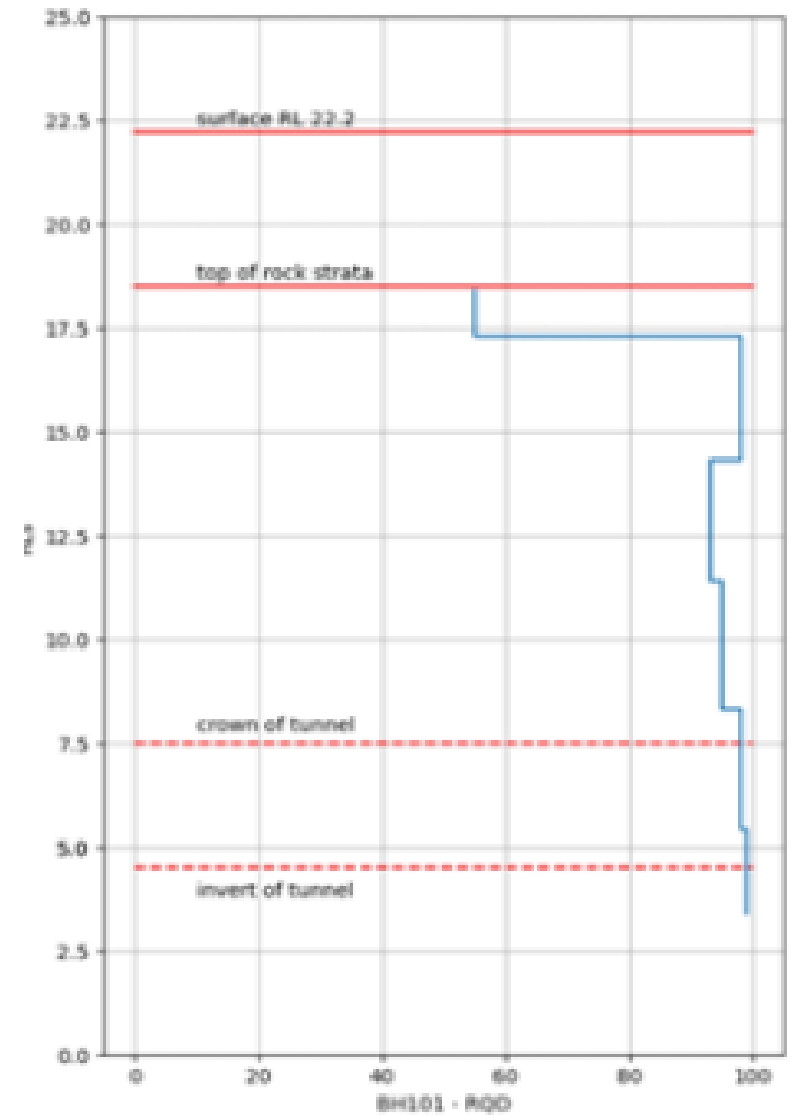
RQD with depth

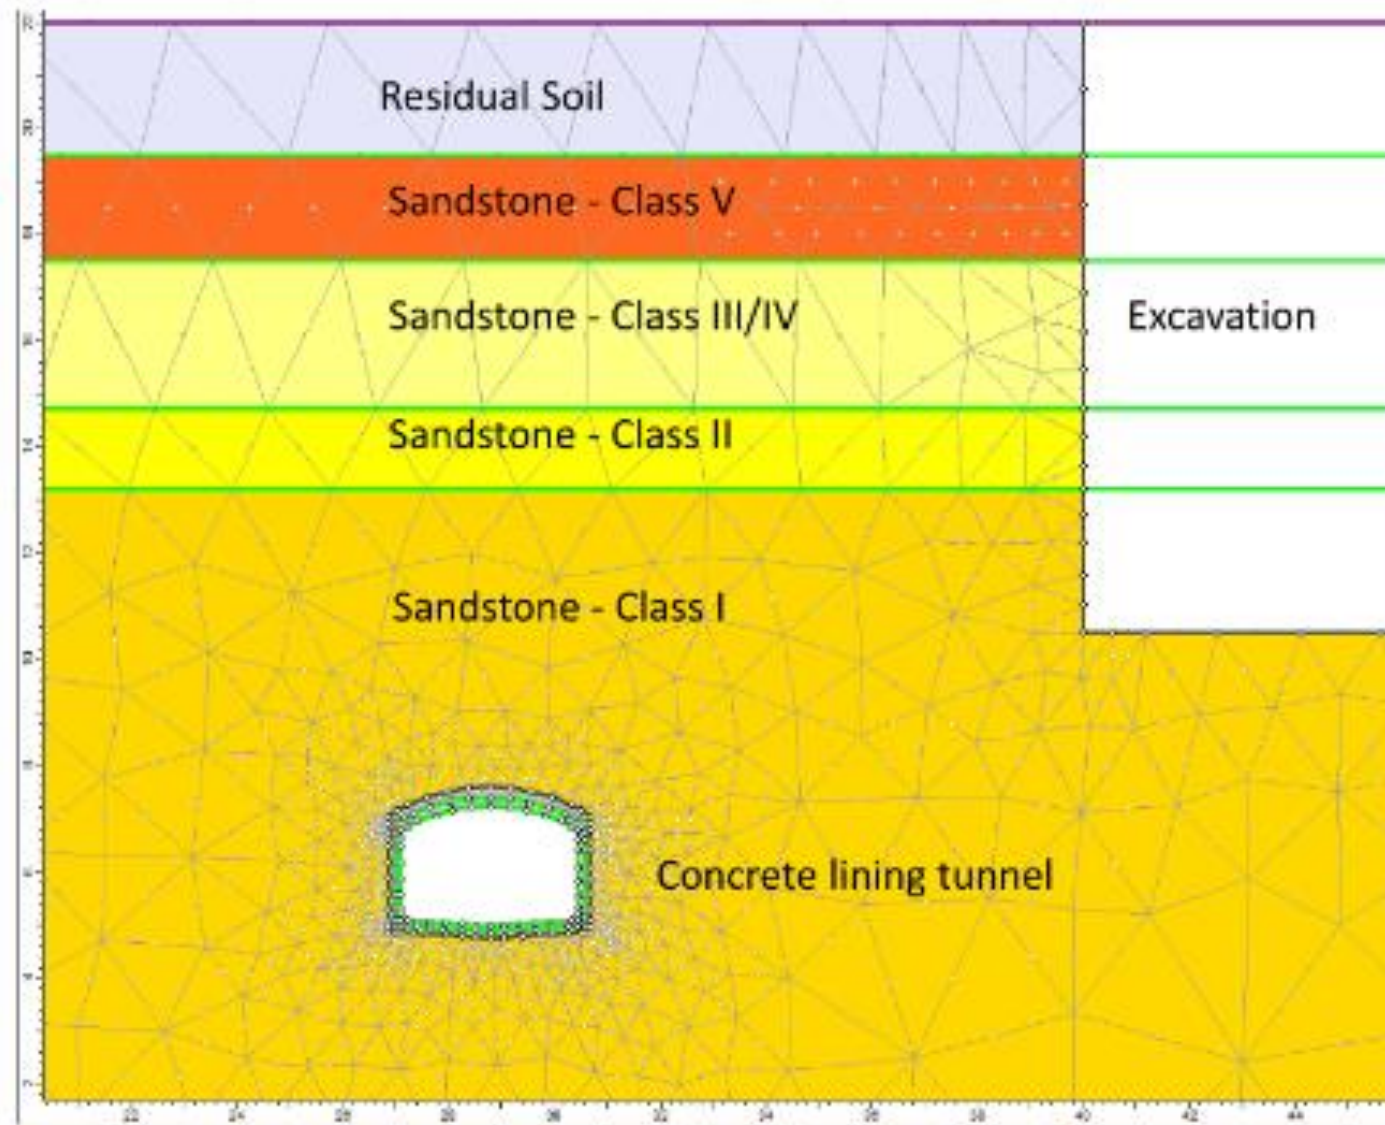
2D Finite element grid

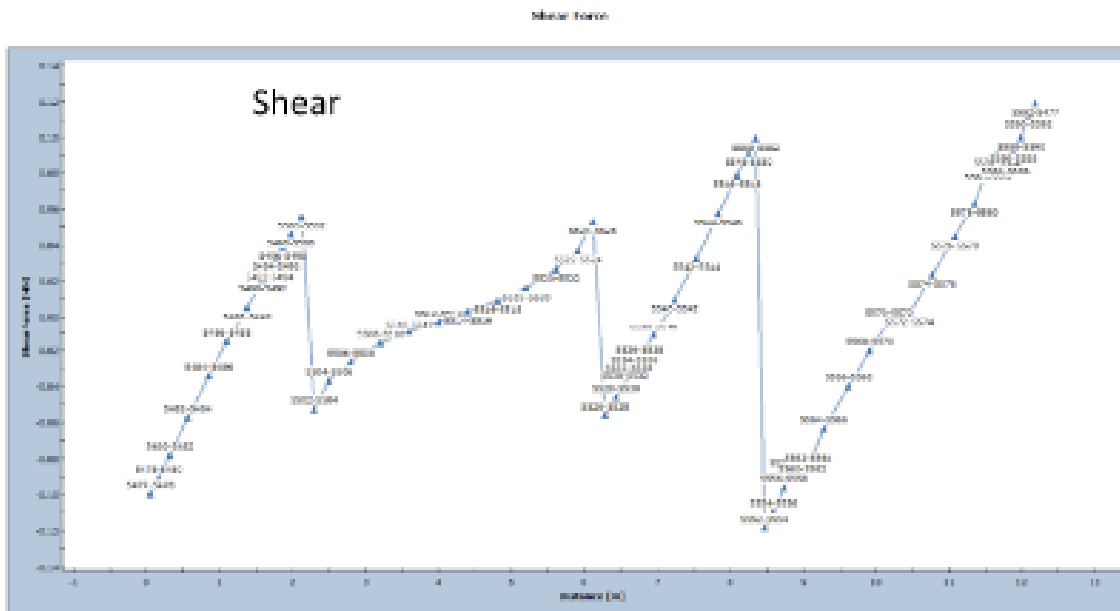
Peak Values – Tunnel Invert

Axial Load (node numbers (5564-5566) and (5578-5580))

$$0.113\text{MN or }113\text{ kN Axial Stress} = 113 \cdot 1000 / 1000 \cdot 230 = 0.49\text{MPa}$$

Moment (node number 5572 mid-span)

$$0.05\text{MNm or }50\text{ kNm or Tensile Fibre Stress} = M/Z - \text{Axial Stress}$$

Shear (node numbers (5552-5554) and (5532-5477))

$$0.12\text{MN or }120\text{ kN Shear Stress} = 120 \cdot 1000 / 1000 \cdot 230 = 0.52\text{MPa}$$

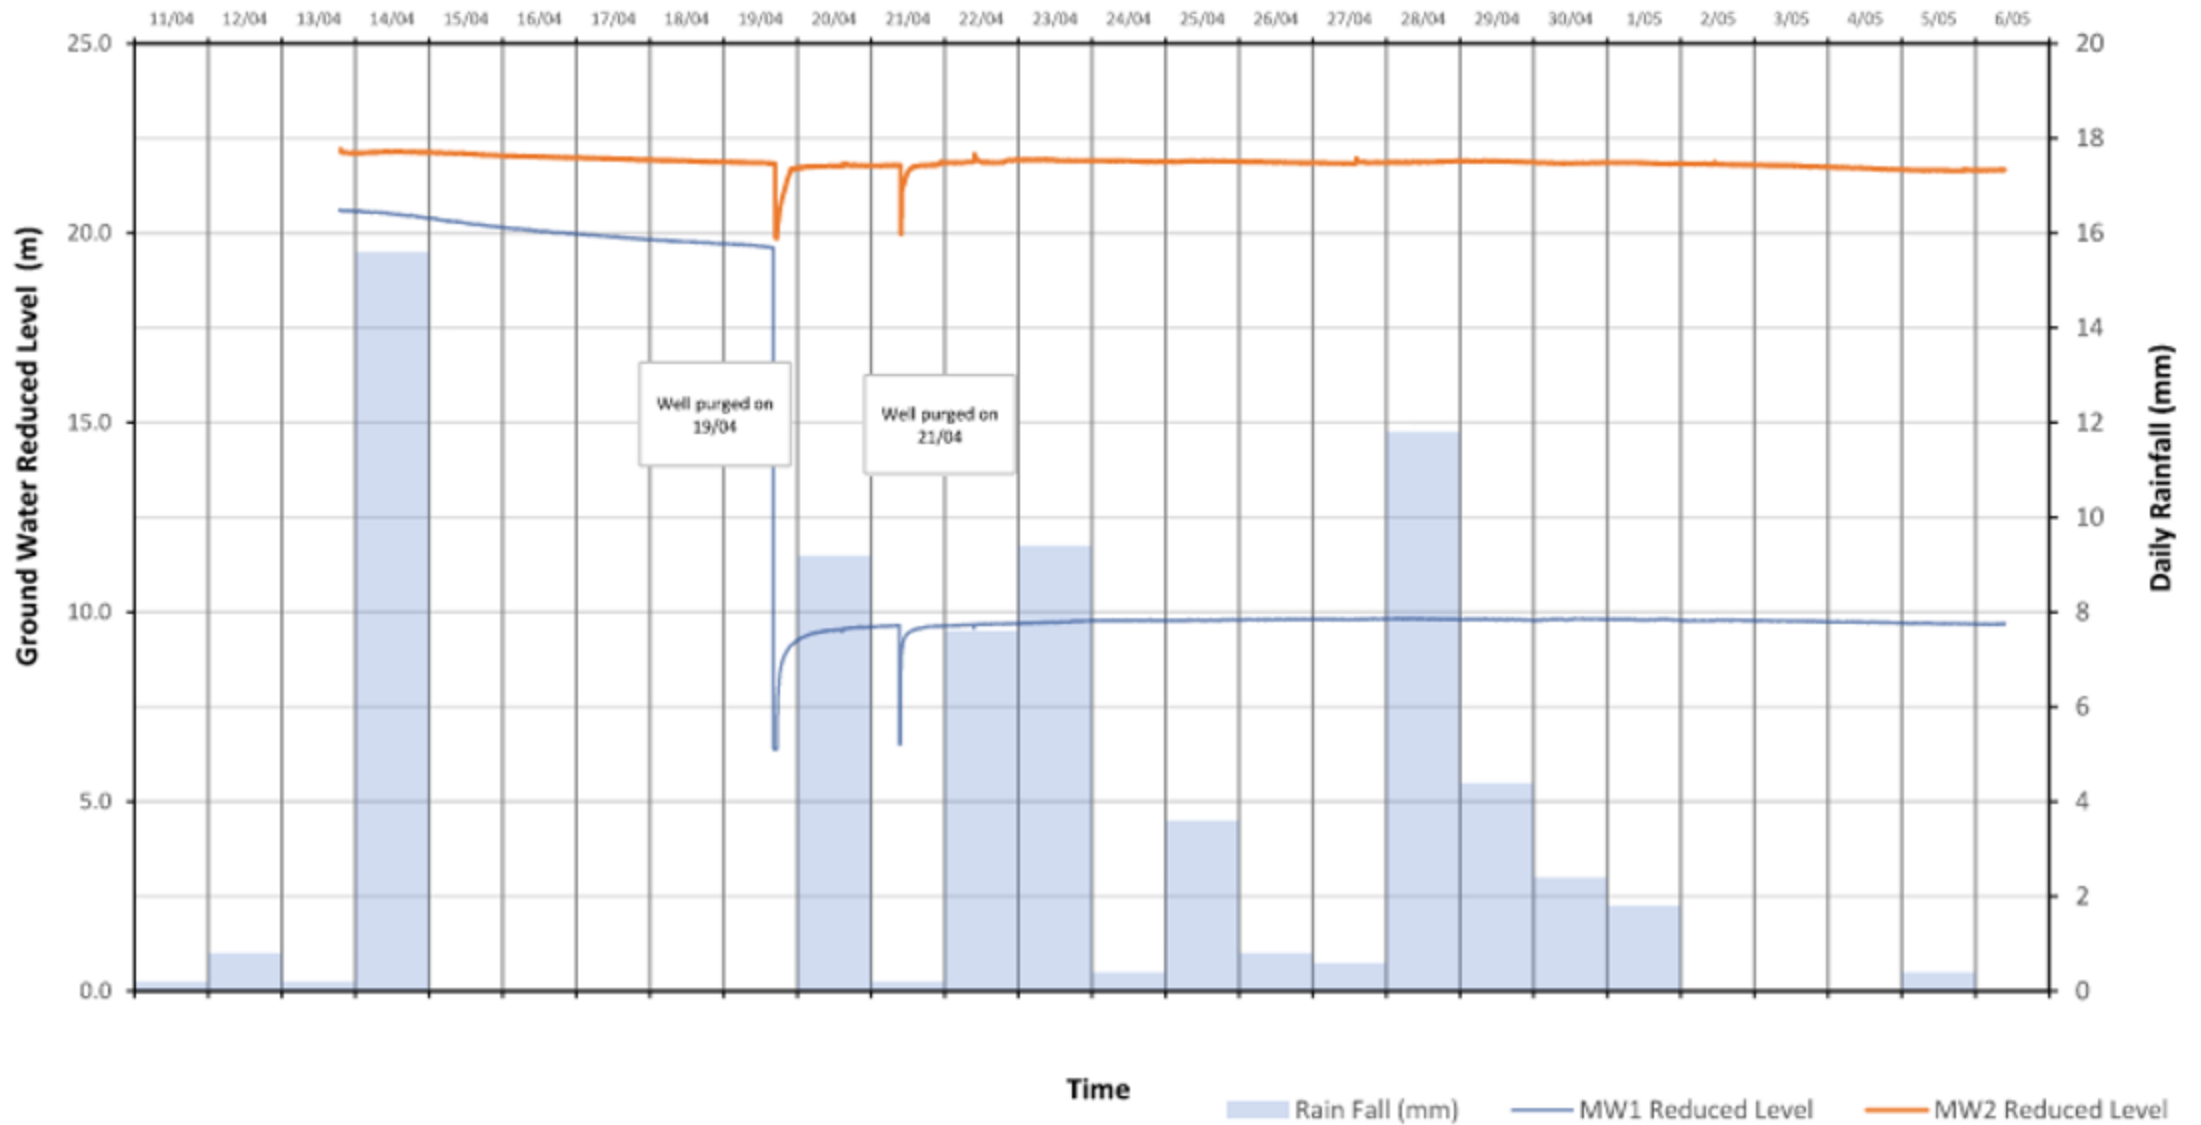
Installation and readings from piezometers
(confirmed predicted perched water table)

5. External water pressure. The basement excavation because it is drained will maintain a the existing a water table level over the crown of the tunnel whatever the rainfall or ground conditions. Both the piezometer results given in Appendix D and the ground water load calculations in Appendix B when considered together confirm that the tunnel lining has not be impacted by external ground water pressure.

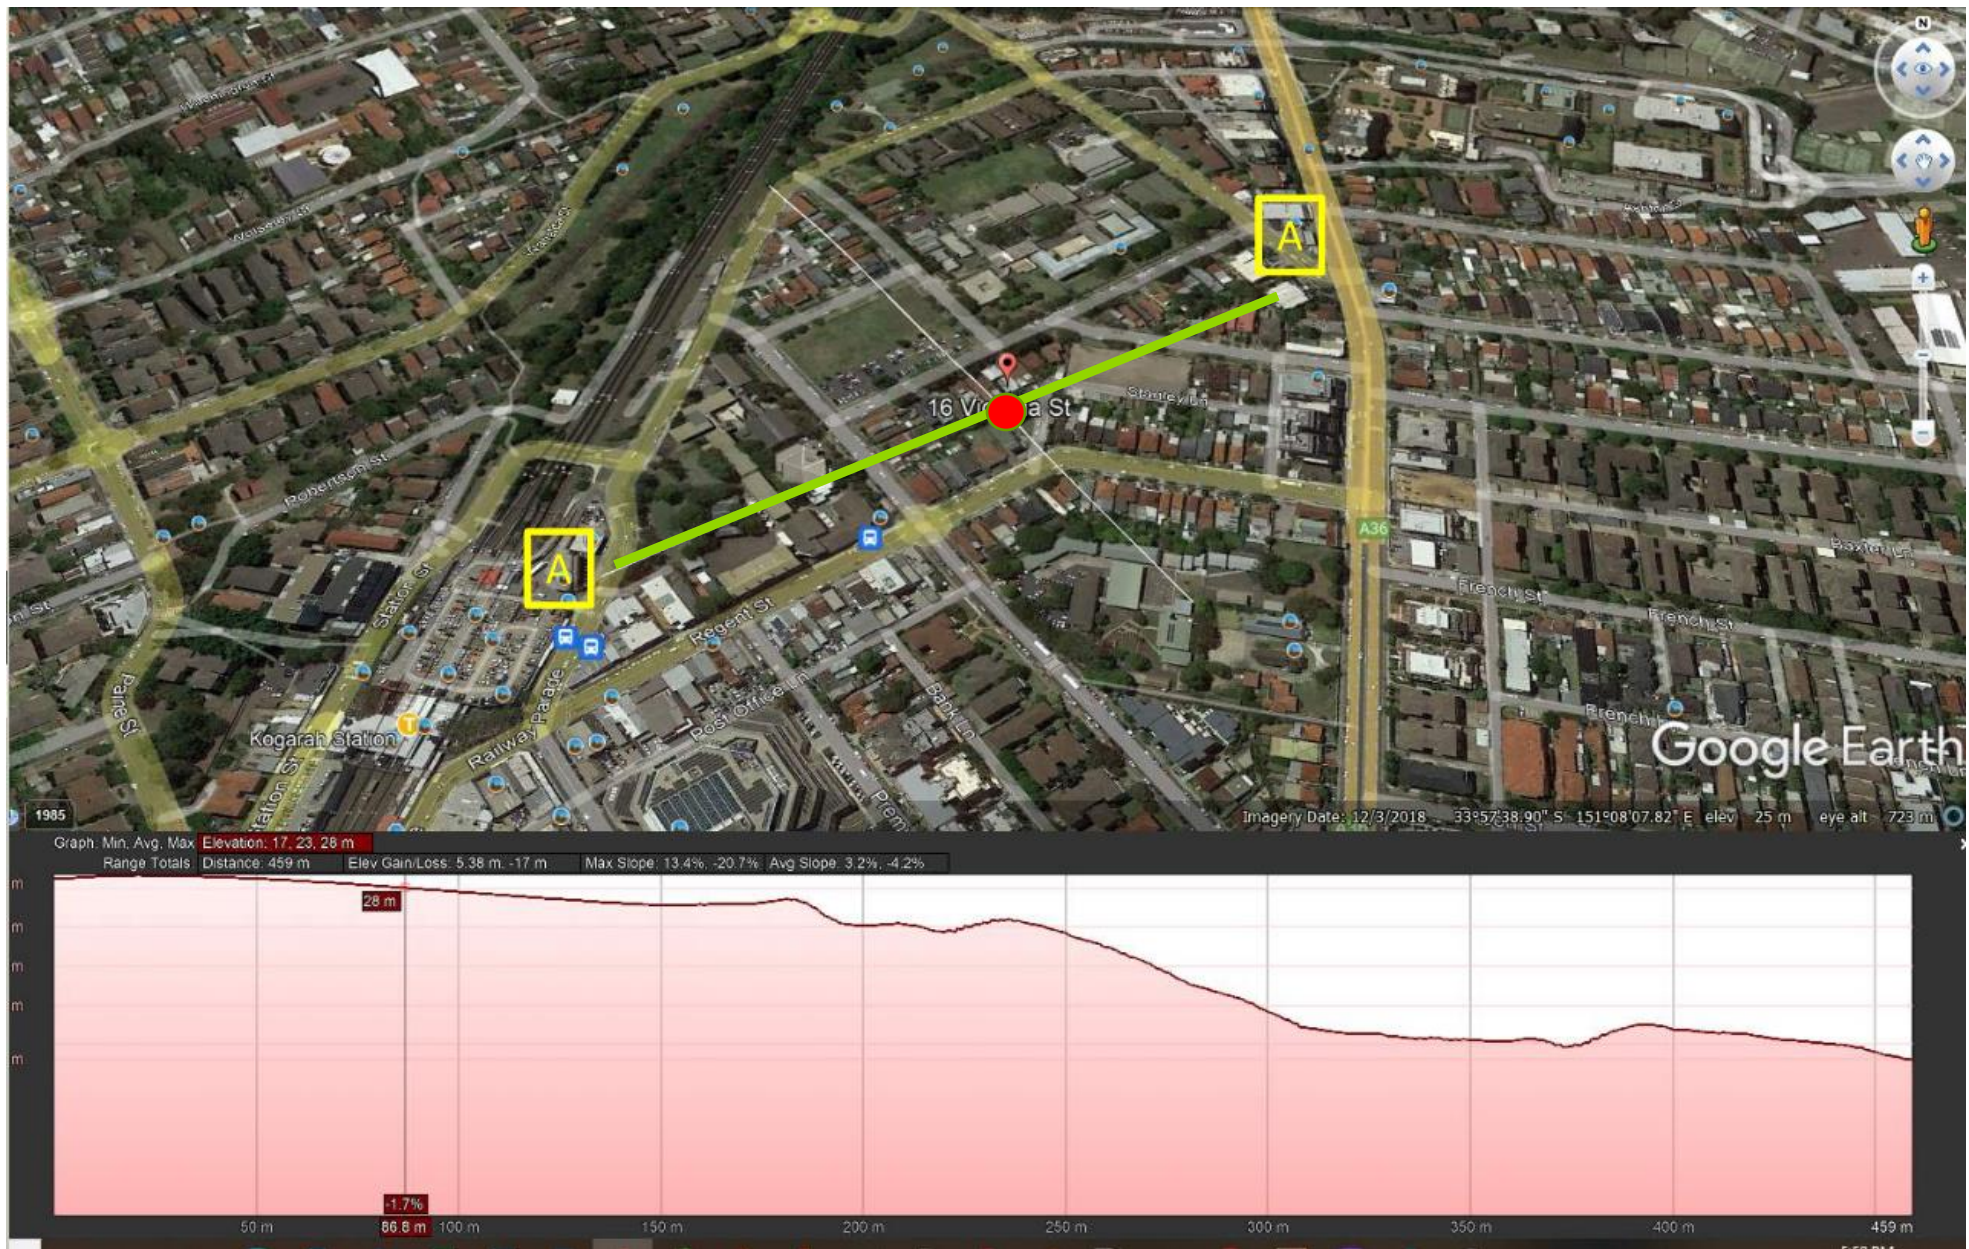
The site is on a high point in the area (section A-A)

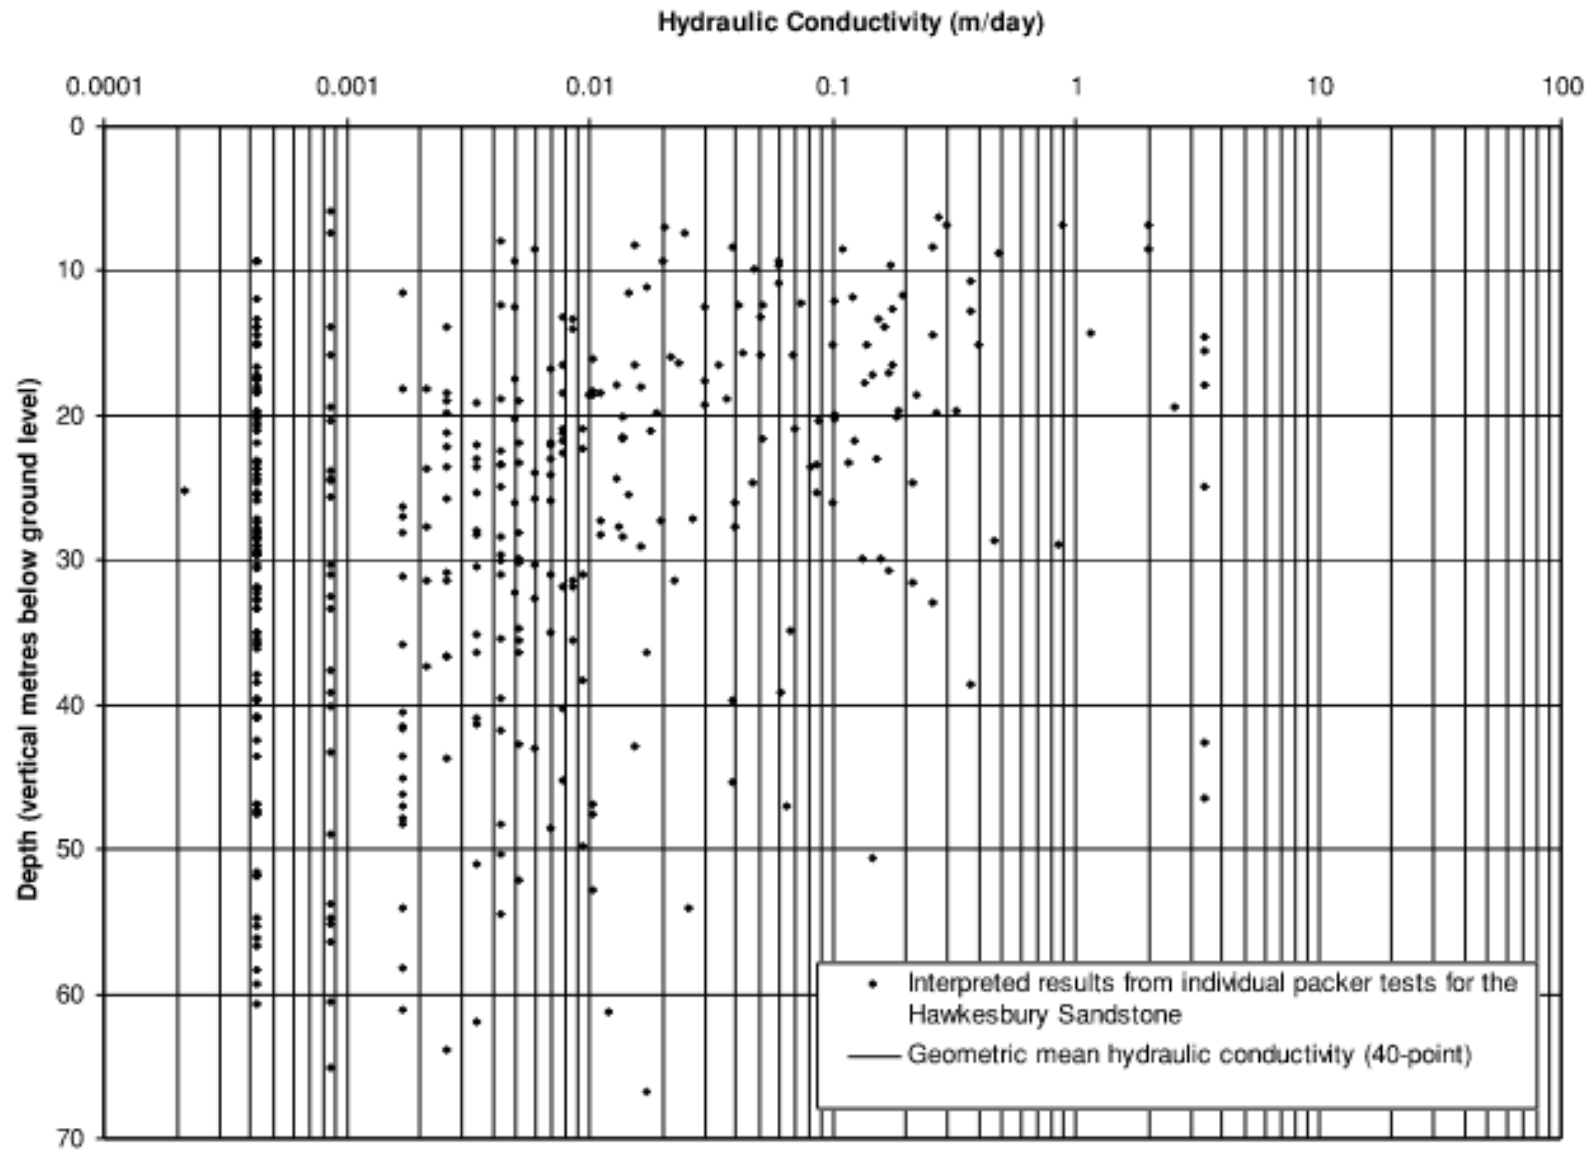
Hawkesbury Sandstone - hydraulic conductivity with depth
